Excavation of the Ara Metua (*Ara Nui o Toi*) at Arai te Tonga

Preliminary report May – June 2018

Cook Islands Tangible Cultural Heritage (CITCH) 2018 Report 2

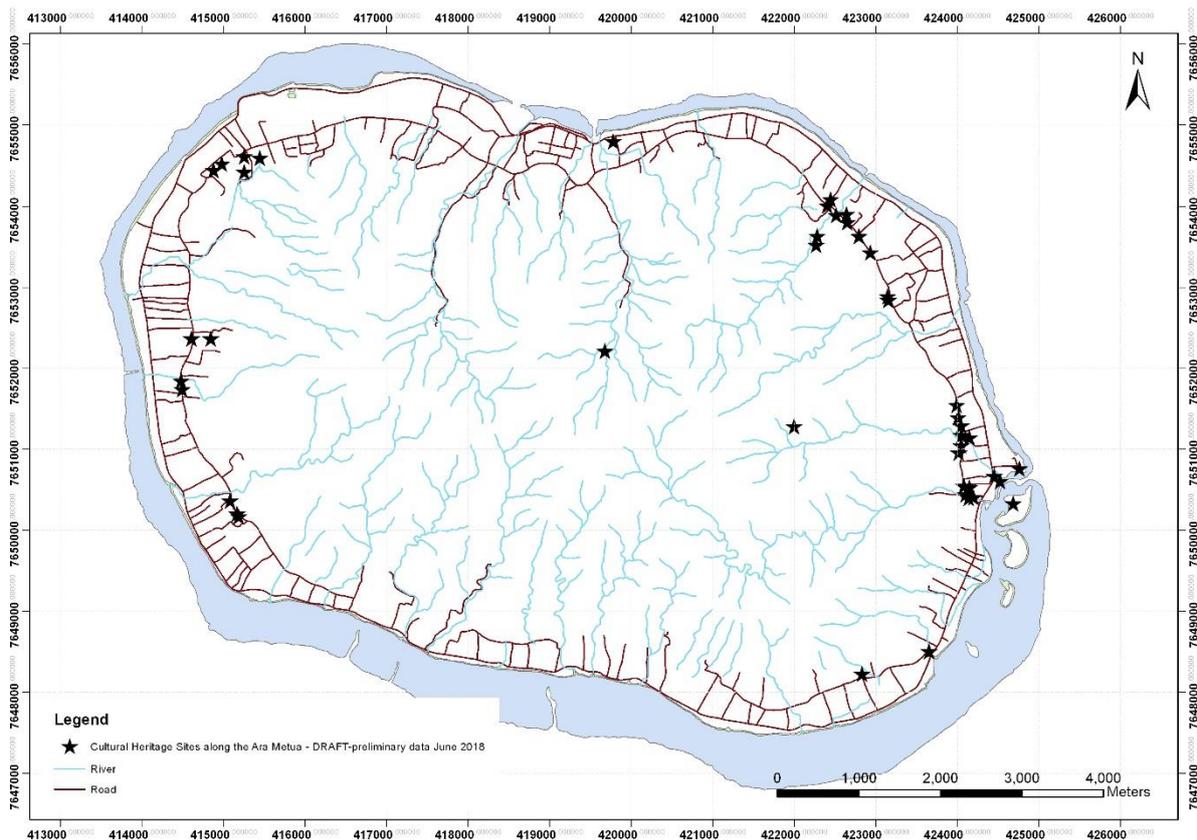
Figure 1. The circuit of the Ara Metua on Rarotonga.

- Figure 1. Map of Rarotonga showing the circuit of the *Ara Metua*, as represented by the contemporary inner road, note absent sections in the southern sector (from Campbell 2001).

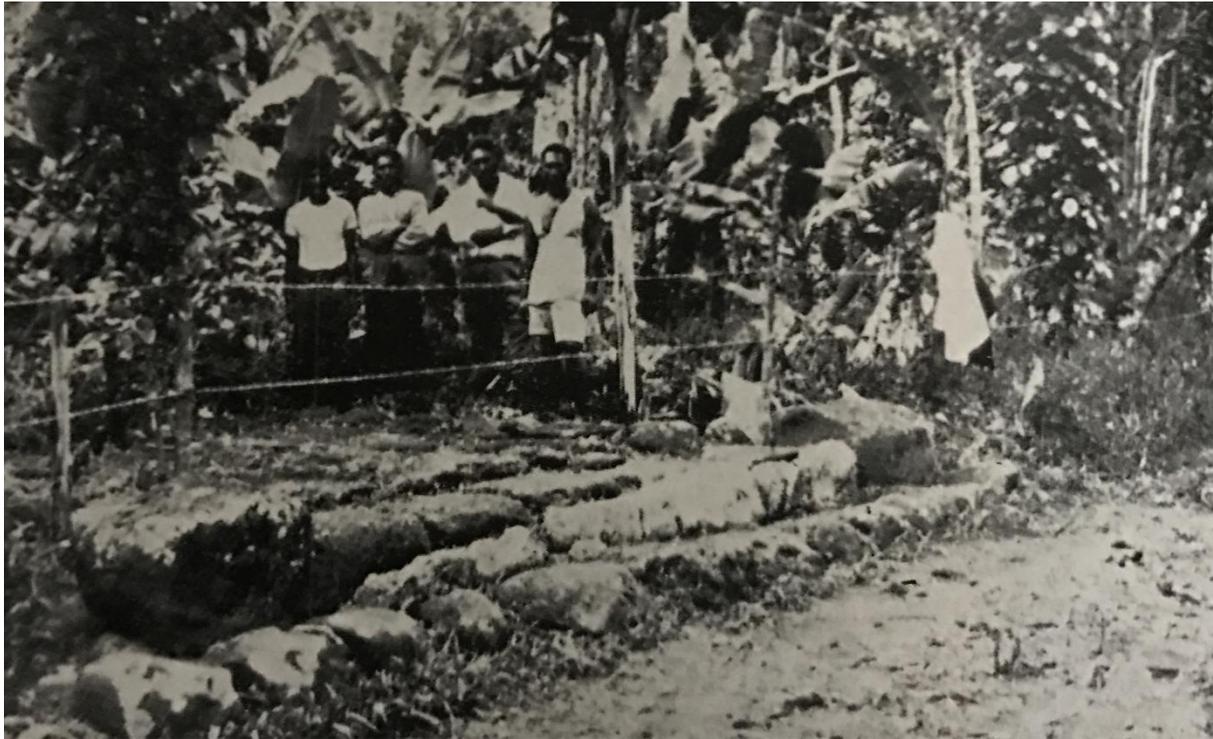
Figure 2. Photograph of the Ara Metua at Arerangi in 1926 (from Buck 1927).

The latter observation is demonstrated by an illustration of a section of the road near the *marae* of Arai te Tonga (Fig. 2). Here the southern curb of the Ara Metua creates a step, behind which a narrower paved road leads back towards ‘the site of a house known as *Harerangi*’ (ibid, 212). This location is now known to be the *marae* of Arerangi, which according to Percy Smith did contain a house ‘where the *ariki* or high chief (some member of the Makea family) of the island usually lived’ (1903, 219). However, as Buck (1927, 212) points out, Percy Smith in a published sketch of the Arerangi mistakenly described the stepped curb of the Ara Metua where it met the Arerangi entrance to be a series of stone seats. Overall, the accounts of both Percy Smith (1903) and Buck (1927) contain crucial early descriptions of the Ara Metua that have been followed and reproduced by subsequent researchers (e.g. Parker 1974; Campbell 2006), consequently a critical re-assessment is required.

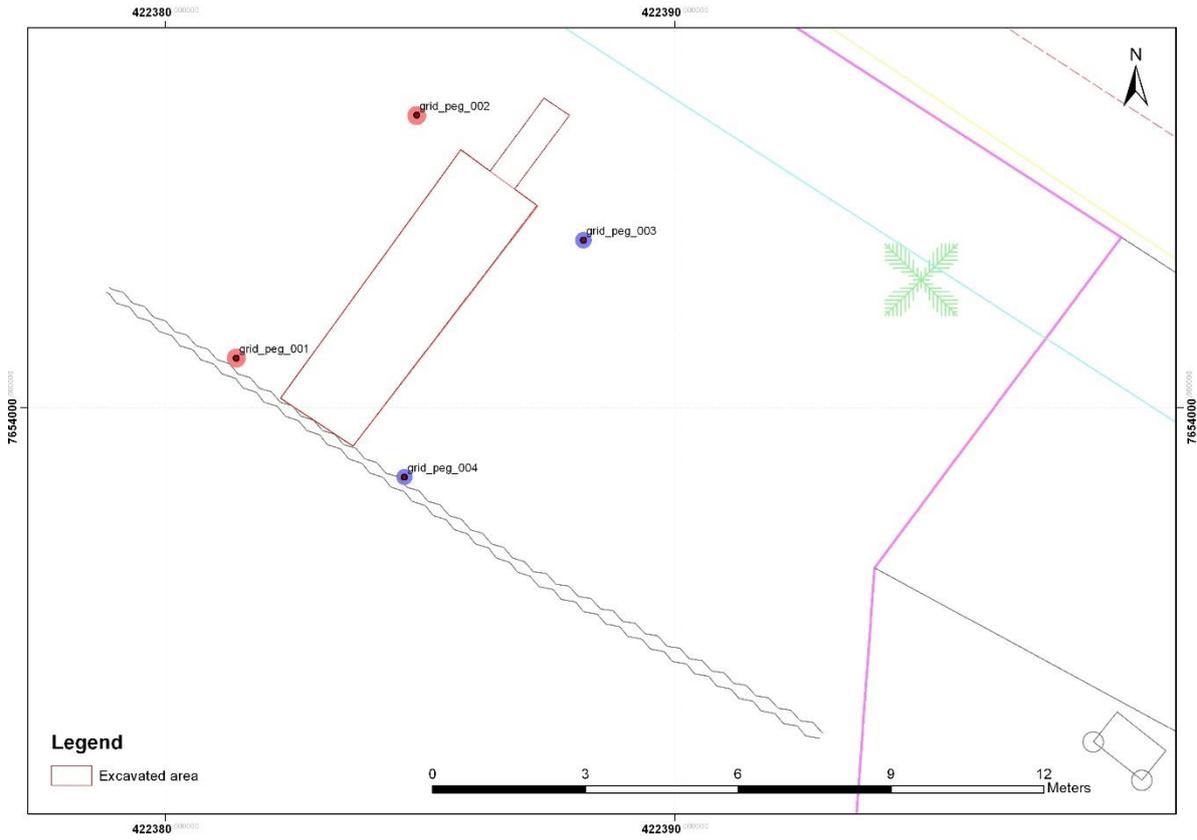
Figure 3. Location of the excavation trench.

Excavations proceeded in 2018 with a 2m x 6m trench cut laterally across the Ara Metua located to the west of Arai te Tonga (Figs. 3 & 4). This position was selected because it was felt that the best-preserved section of road would lie in front of the *koutou*. Furthermore, an old sketch published by Percy Smith in 1903 shows the location of the Ara Metua as it ran between the opposed stone seats.

1920s. As revealed by excavation, this surface had suffered considerable wear which indicates a relatively long life, consequently we can be confident that it stood in this form over a substantial period of time, and may have been quite old when seen by Smith in the 1890s. Judging from the photograph taken by Buck in the 1920s, the road surface at the adjacent *marae* of Arerangi, had become covered by soil (see Fig. 3).

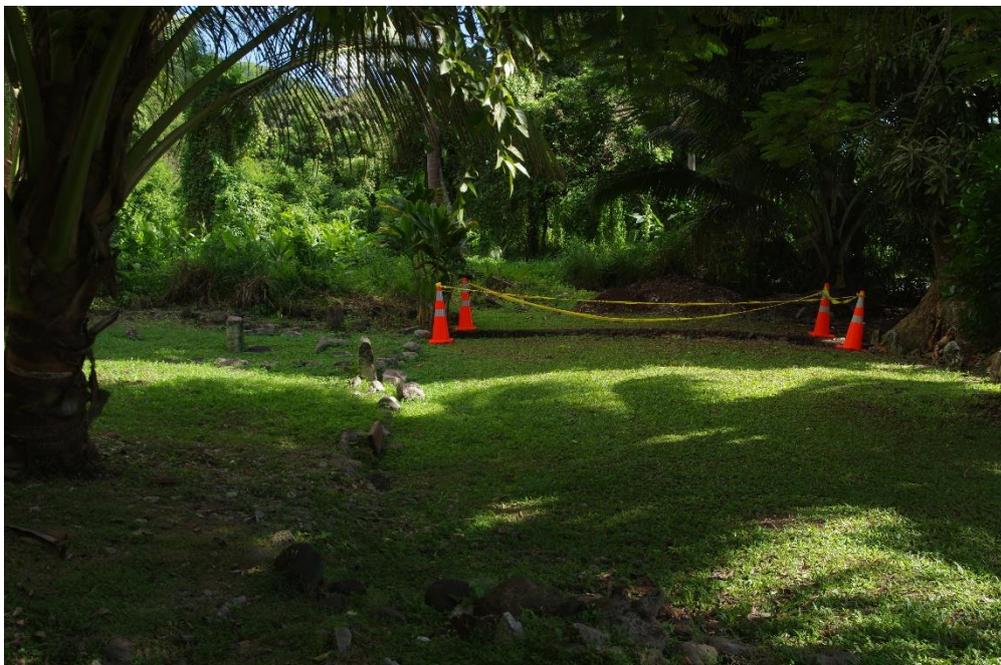
Figure 4. The excavation trench from the east.

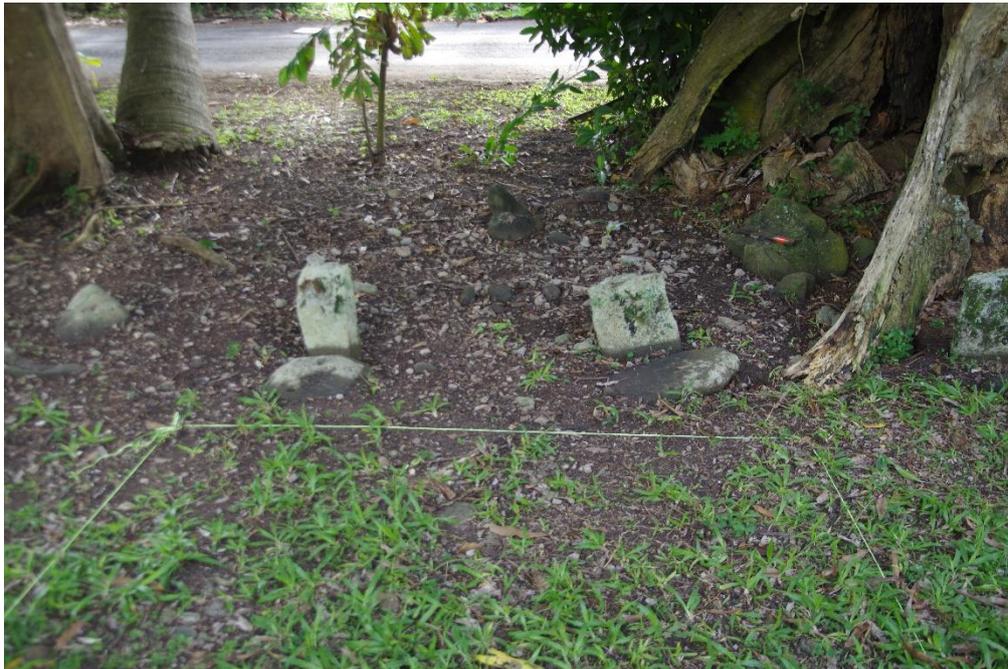
Figure 5. The two stone seats at the northern end of the trench.

The 2018 excavation trench was positioned to section the Ara Metua at a location slightly to the west of the *koutou* adjacent to two stone seats [003 & 004] (Fig. 5). Here the stratigraphy of the trench will be described in reverse order (bottom/oldest – top/most recent).

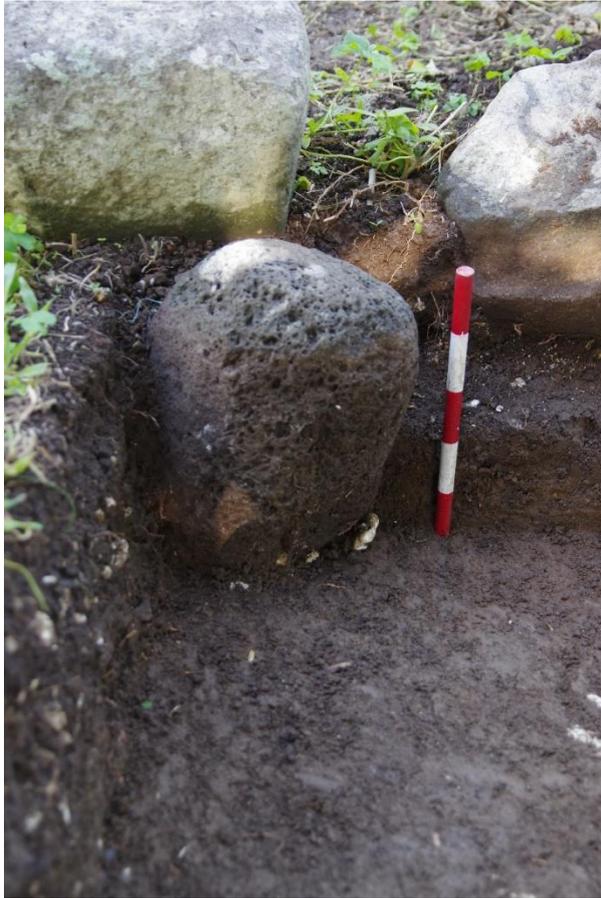
Figure 6. The basalt pillar [021] set into the old land surface [008] directly in front of the *marae* facing stones [005].

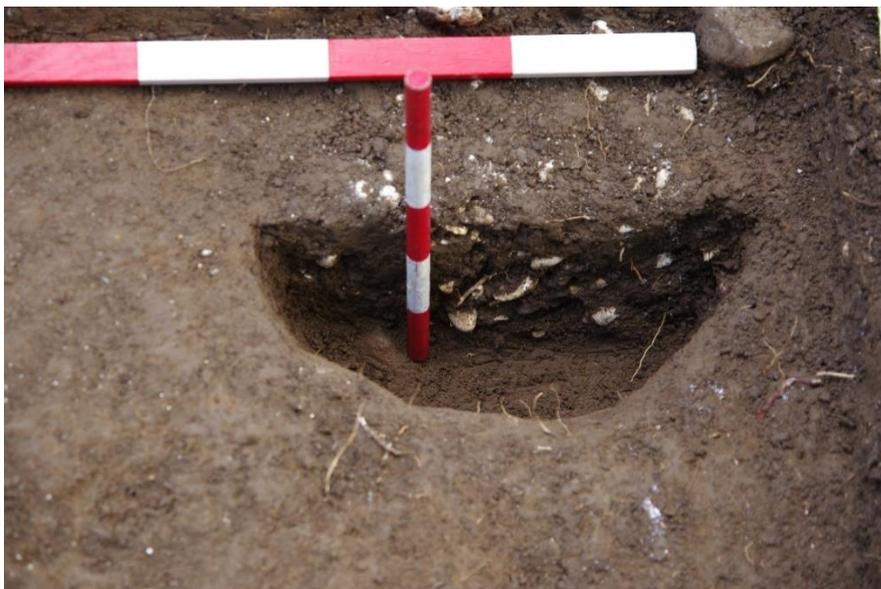
Figure 7. Pit/socket [014] with a *kiri-kiri* rich fill [015] at the southern end of the trench.

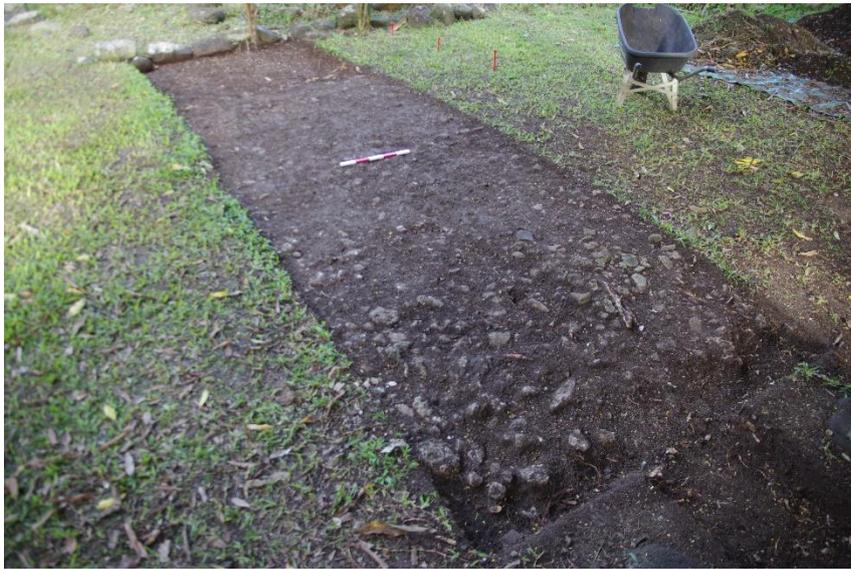
Figure 8. Upper road surface [002] from the NW, note the convex camber of the surface.

The 'back road' was shifted away from Arai te Tonga in the 1980s and now occupies a situation c. 6m to the north of the old route of the Ara Metua that originally ran along the front of the *Koutou* of Arai te Tonga and *marae* of Arerangi. Excavation commenced with the removal of the thin topsoil [001], which revealed a broad road surface [002] with a width of c. 4.5m. This is undoubtedly the final mid-twentieth century road that was 'metalled' by hard-packed basalt and coral cobbles (some of which were visible before excavation commenced projecting through the ground surface). As may be expected, the road surface was extremely compact and hard and displayed a convex camber (Fig. 8).

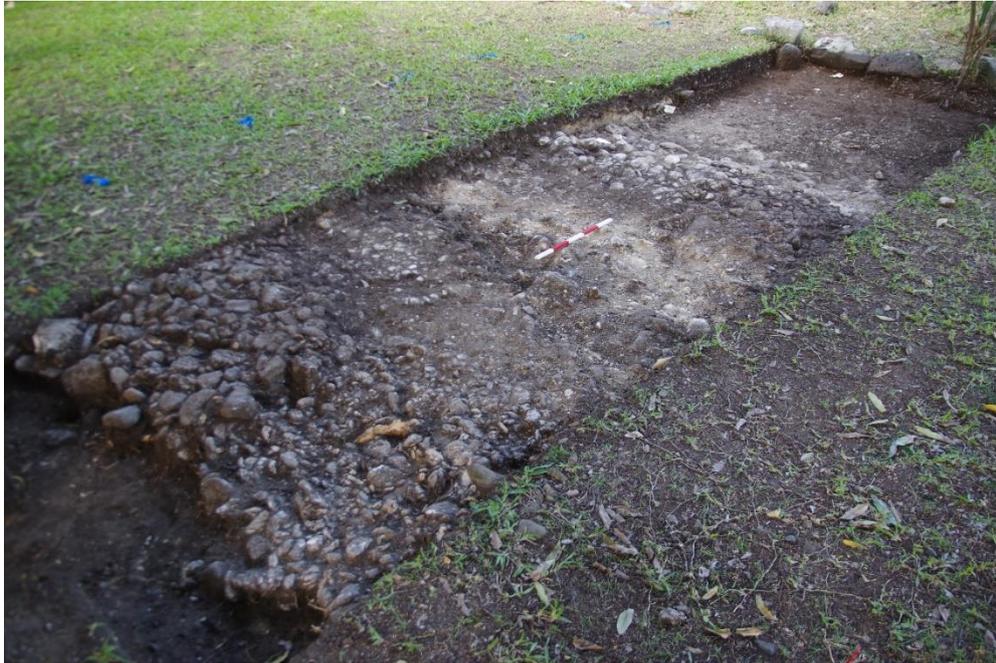
Figure 9. The intermediate narrow road surface paved with coral blocks from the NW. Note the central disturbance and different coral forming the southern and northern sides of the road.

The disturbed and truncated central area of the secondary road (see Fig.9) appears to also be a product of both wear and disturbance by the later cut [017] and its fill [016]. In places, the wear had actually revealed the road-surface make-up [024], which consisted of hard-packed and angled coral with occasional basalt lumps.

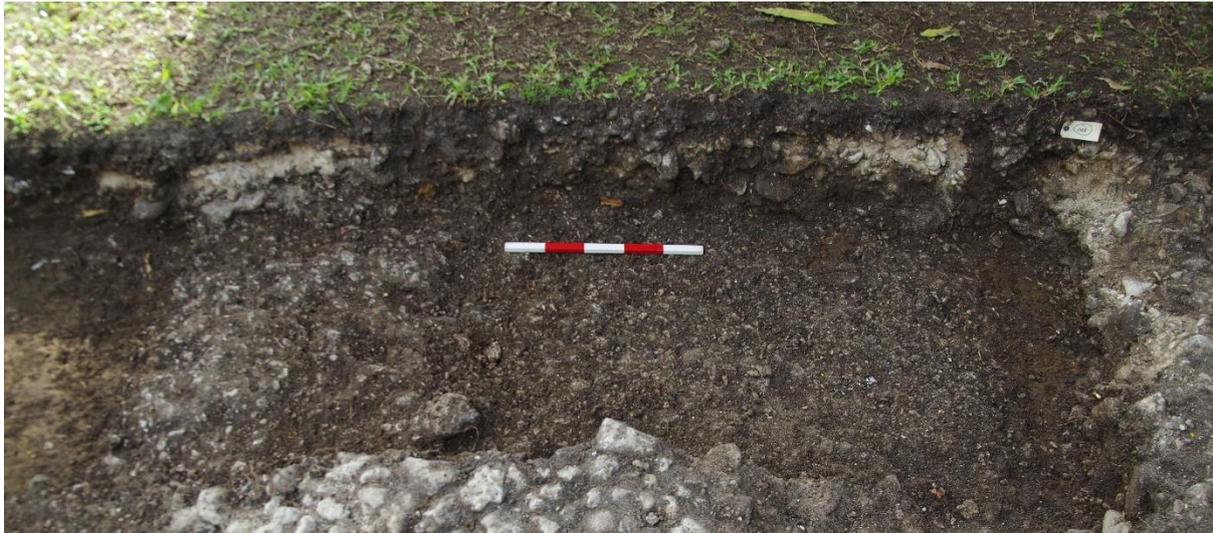
Figure 10. View of the primary *kiri-kiri* road surface [026] of the Ara Metua, showing the base of the higher cut [017] to the right and the original raised bank or curb [027] to the left.

With considerations of preservation in mind, the excavation of the second road surface and its make-up [024] was restricted to a 1m wide slot adjacent to the west baulk of the trench. Here it was found that the make-up/foundation [024] of the secondary road covered a compact layer or surface of smaller horizontally laid basalt and coral stones [025], which on further cleaning was found to be a partial (central) resurfacing episode of an older, underlying road surface. Directly beneath resurfacing layer [025], a spread of variable thickness c. 0.06m thick, of *kiri-kiri* [026], formed a primary road surface. The edge of this road was defined by a raised bank of *kiri-kiri* [027], c. 0.12m high (Fig. 10).

The earliest Ara Metua was defined along its edges by a raised heap or low bank of *kiri-kiri*, which also served as a form of curbing (Fig. 10). The profile of the original road was slightly concave, a feature paralleling the profile of the *Ara Moai* on Rapa Nui. The duration of the initial Ara Metua is difficult to know, suffice to note it had been resurfaced at least once by laying a deposit of small chunks and chips of basalt and coral.

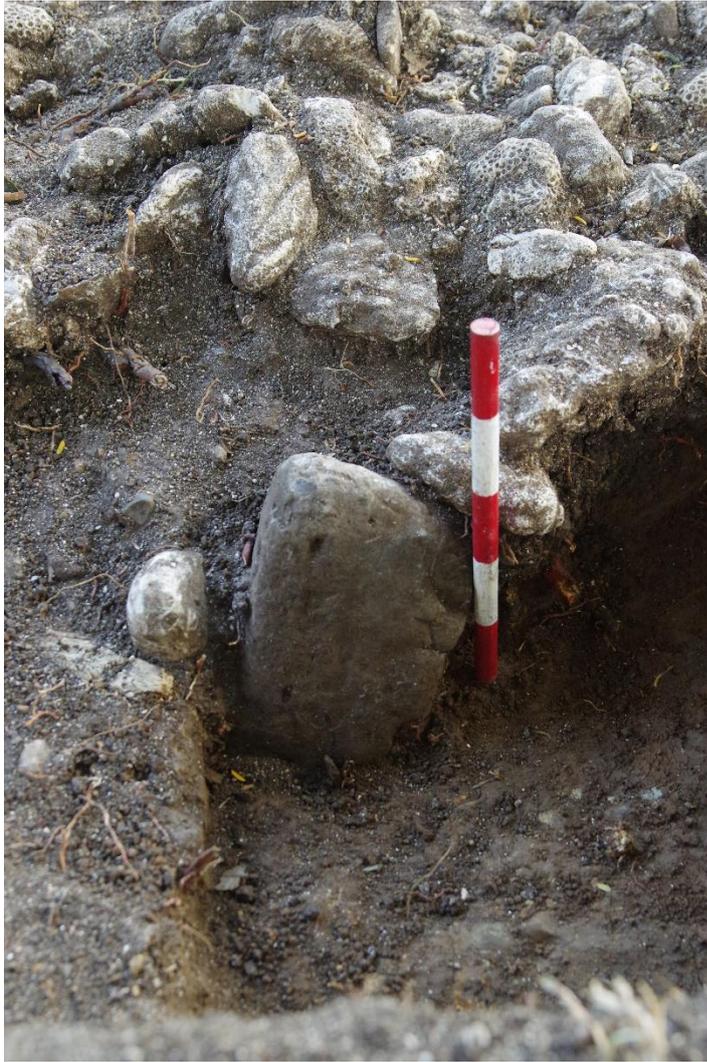
Figure 11. The single *in situ* example of the basalt curbing [028] on the northern edge of the phase 2 road.

After the removal of the latest road surface [002], a series of coral sand layers and dumps [007] were revealed, particularly underlying the southern section of road [002]. This material clearly represents the foundation material deposited to enable road-widening. Excavation of this material exposed the earlier (secondary) road, which was narrower, measuring c. 3.5m in width. Significantly, the lower road was surfaced entirely with rammed coral pebbles and blocks (Fig. 9). The only remains of basalt curbing were found on the northern edge of the road where a single upright [028] remained *in-situ* (Fig.11).

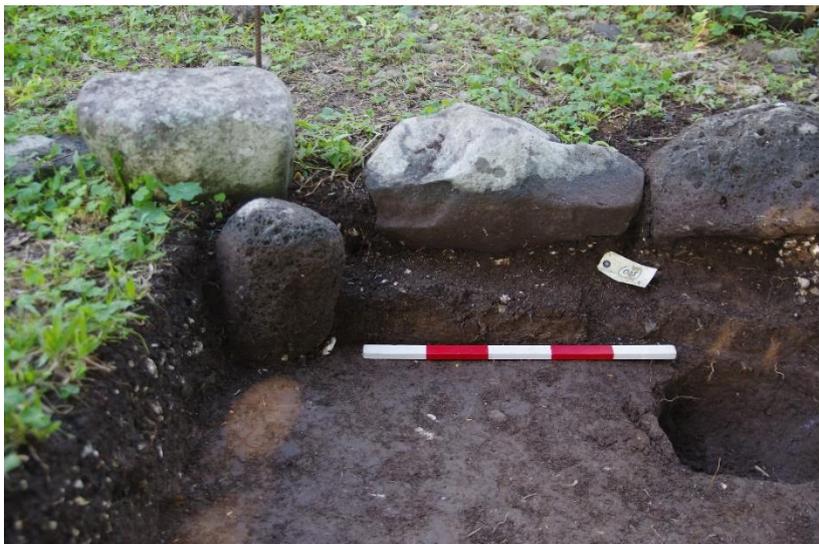
Figure 12. The basalt boundary [005] stones of the western section of the Arai te Tonga *koutou* set on a layer of *kiri-kiri* [006], overlying the OLS [008], which ran down to the first Ara Metua.

While the 2018 excavations did not extend into the Arai te Tonga *koutou*, the trench did continue to the outer boundary stones on its western side (Fig. 12). These were clearly set on a layer of *kir-kiri* that ran downslope to conjoin with the primary *kiri-kiri* surface of the Ara Metua.

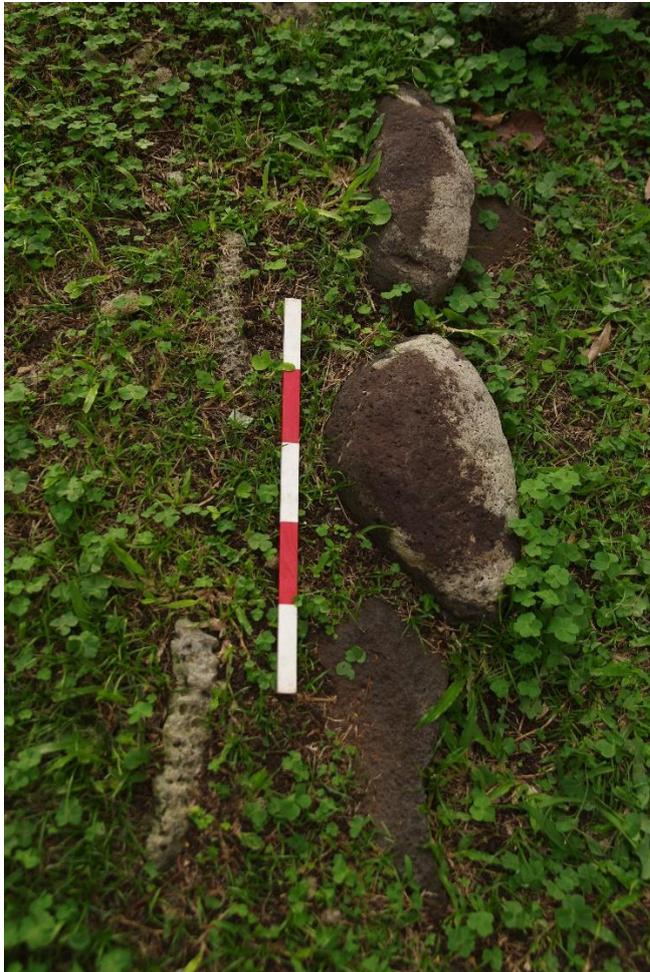
Figure 13. The basalt boundary stones at the east sector of Arai te Tonga lying in front of what appears to be earlier vertical coral facing slabs.

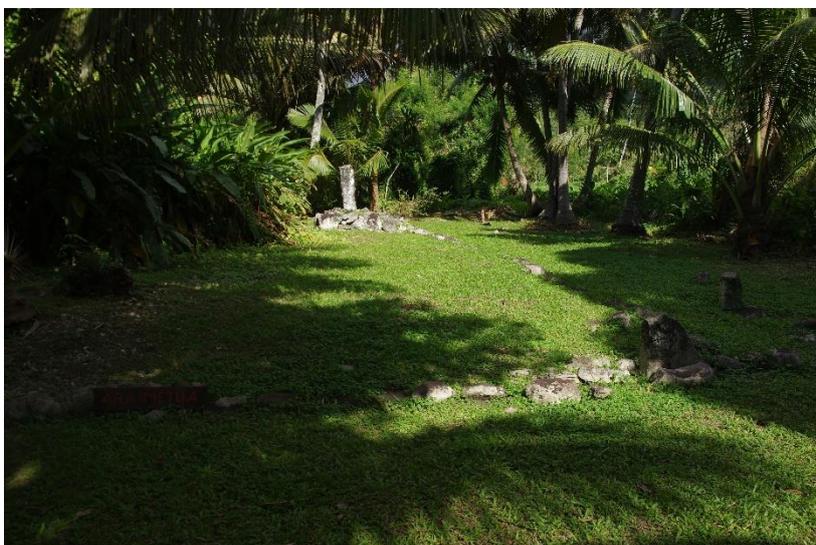
Figure 14. The eastern sector of Arai te Tonga from the north.
