The Norse Waterways of West Mainland Orkney, Scotland

Martin Bates, Richard Bates, Barbara Crawford, and Alexandra Sanmark¹

Summary

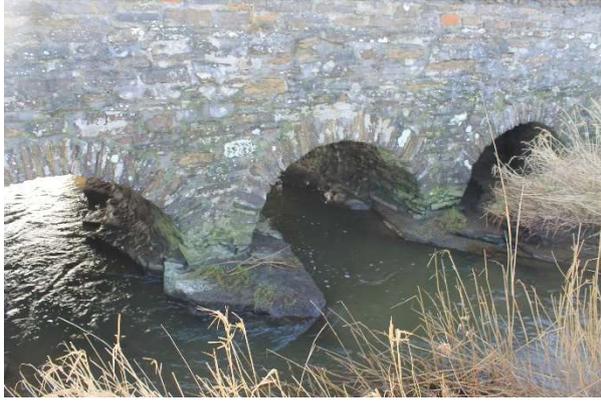
transect near to the Burn of Hackland where the river has cut a channel over 2 m deep into the landscape and infilled the sides with sand and soft muds (Figures 6a and 6b).

Figure 6 a) bridge along Dounby transect showing piers founded on bedrock, b) stream channel cut into bedrock.

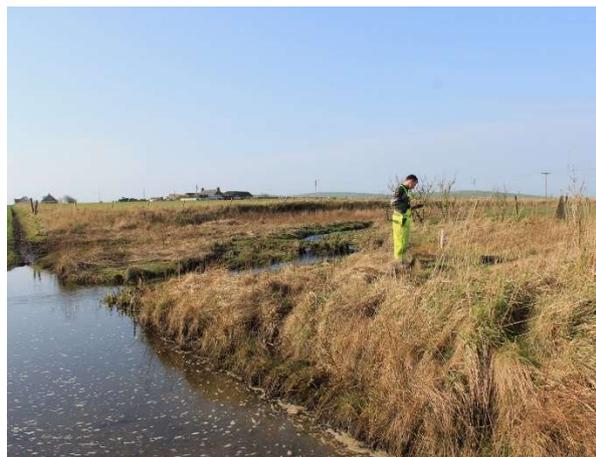
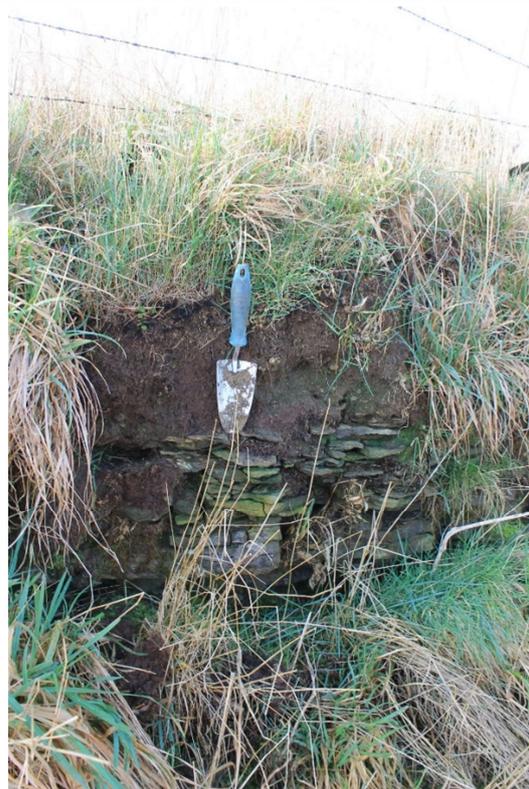
Further to the north a second investigation of the main channel was made to the west of Tounga and to the east of Warth Farm. At this point the river is crossed by a shallow ford and a small stone footbridge. The river-cut bank sections to the west and east of the burn were logged and elevations measured for the heights of bedrock surface (Figure 7). The section to the west showed almost no glacial till on top of the bedrock surface however the section to the east showed a typical thickness of approximately 1 m of till (see photo, Figure 7c).

Figure 7 a) cross section of stratigraphy at Tounga (foot) Bridge near Warth, b) photograph of ford and Tounga (foot) Bridge near Warth Farm, c) west bank of Burn of Warth showing bedrock cut section (trowel for scale 20 cm).

This interesting site exhibits the results of downcutting by the river into the underlying till and bedrock sediments (Figure 7). Till exists overlying bedrock below alluvium to the east while to the west the till is absent and the bedrock is only overlain by alluvium/colluvium. It is noted that the bedrock surface is approximately 1.5 m higher on the west. This evidence implies that the erosion of the cutting in which the modern river lies predates the deposition of the till. In such a low-lying environment the situation of this bluff or cut bank area could be significant as it sits on a wide bend in the palaeo- and present river setting. ArcGIS was used to further analyse the topographic significance of the location by conducting a visibility analysis (line of sight) from the top of the bank near to Warth Farm. The
